HCAT PROGRESS REPORT SEPTEMBER 2002

TEST 1: MLG FATIGUE TEST

TEST 3: PISTON FATIGUE TEST

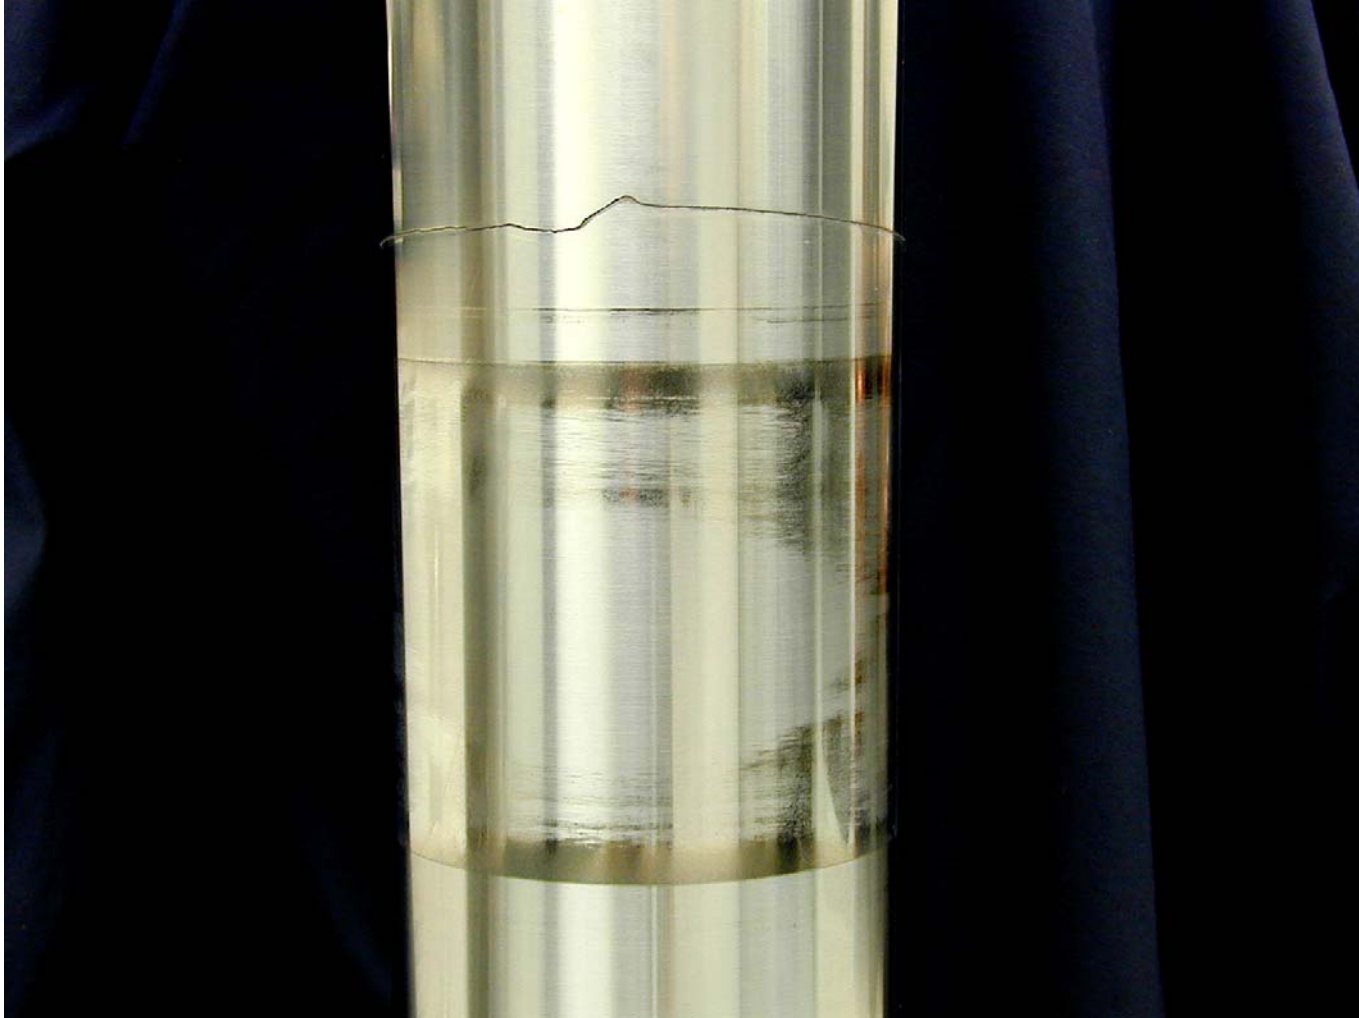
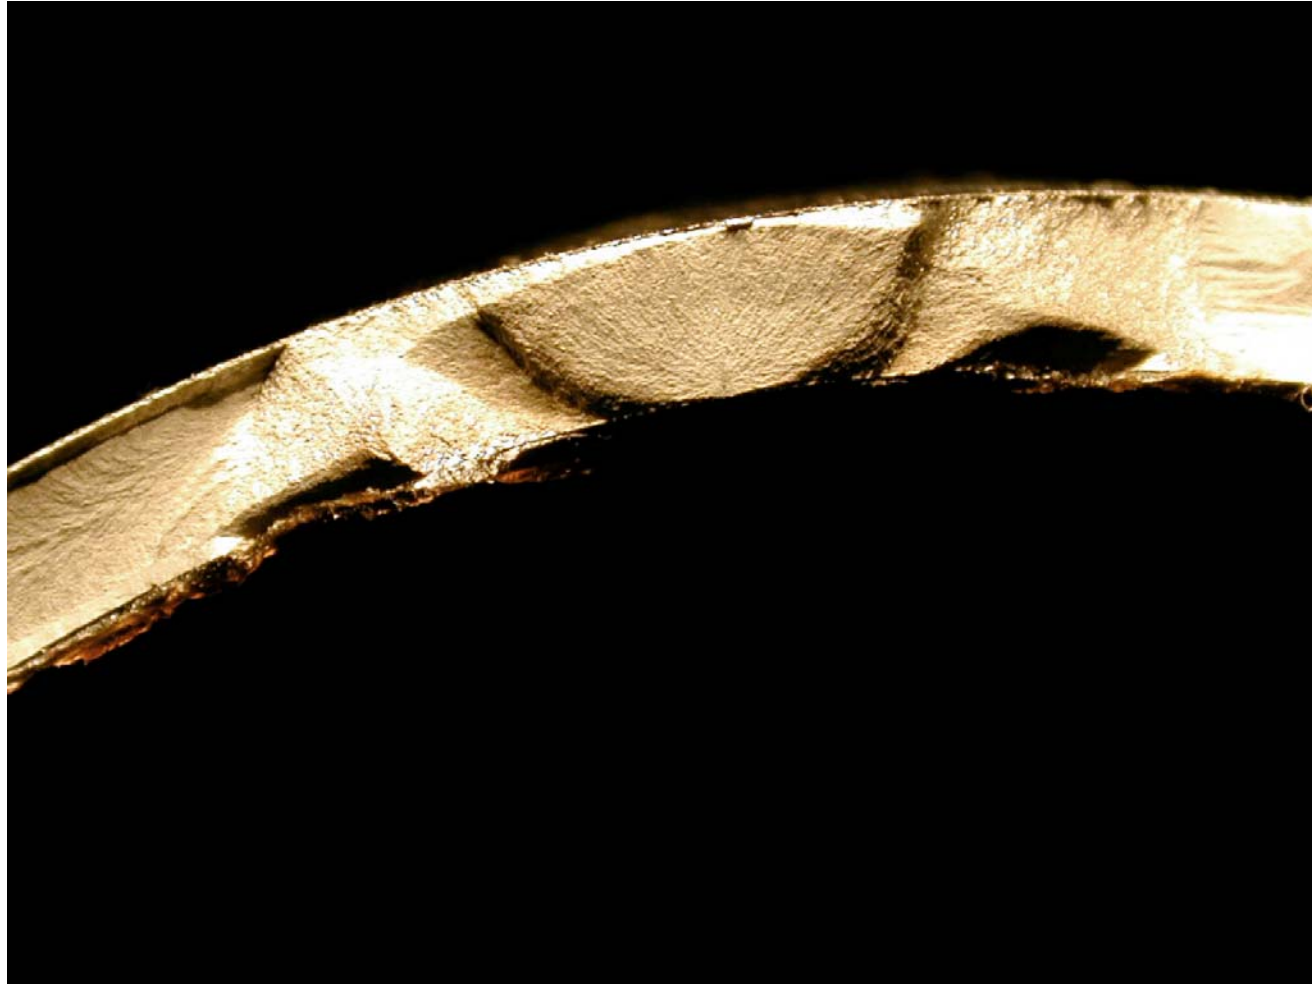
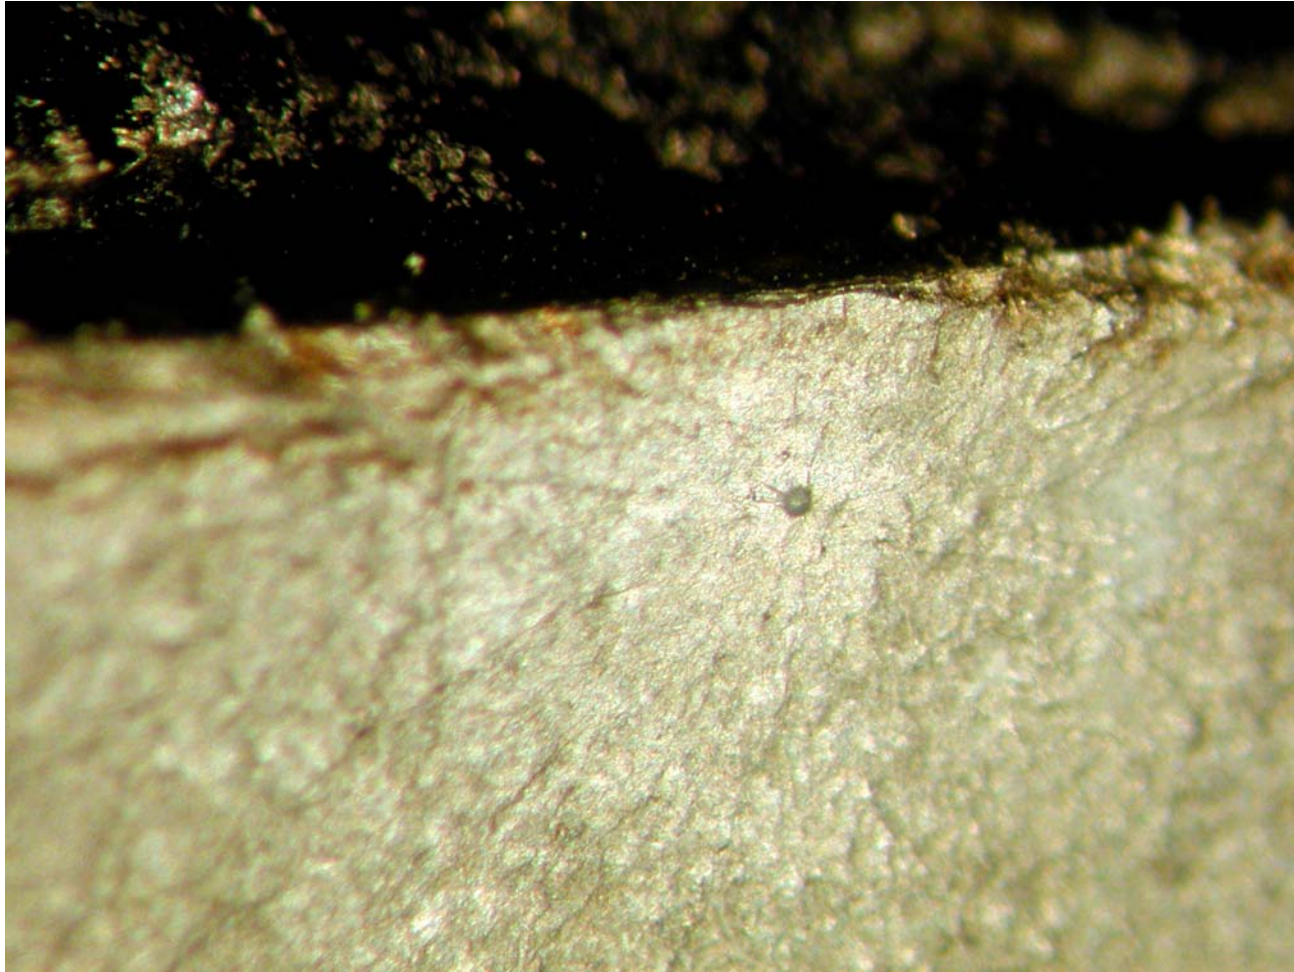
- **1st chrome plated piston:**
285,000 + 122,000 cycles. ~100ksi at notch
- No spalling of coating prior to failure. Some surface wear noted on chrome plating.
- **Piston failed at notch.**
Crack initiated near the piston inner diameter at an **inclusion** - extended circumferentially outward.

CHROME PLATED 5 INCH PISTON

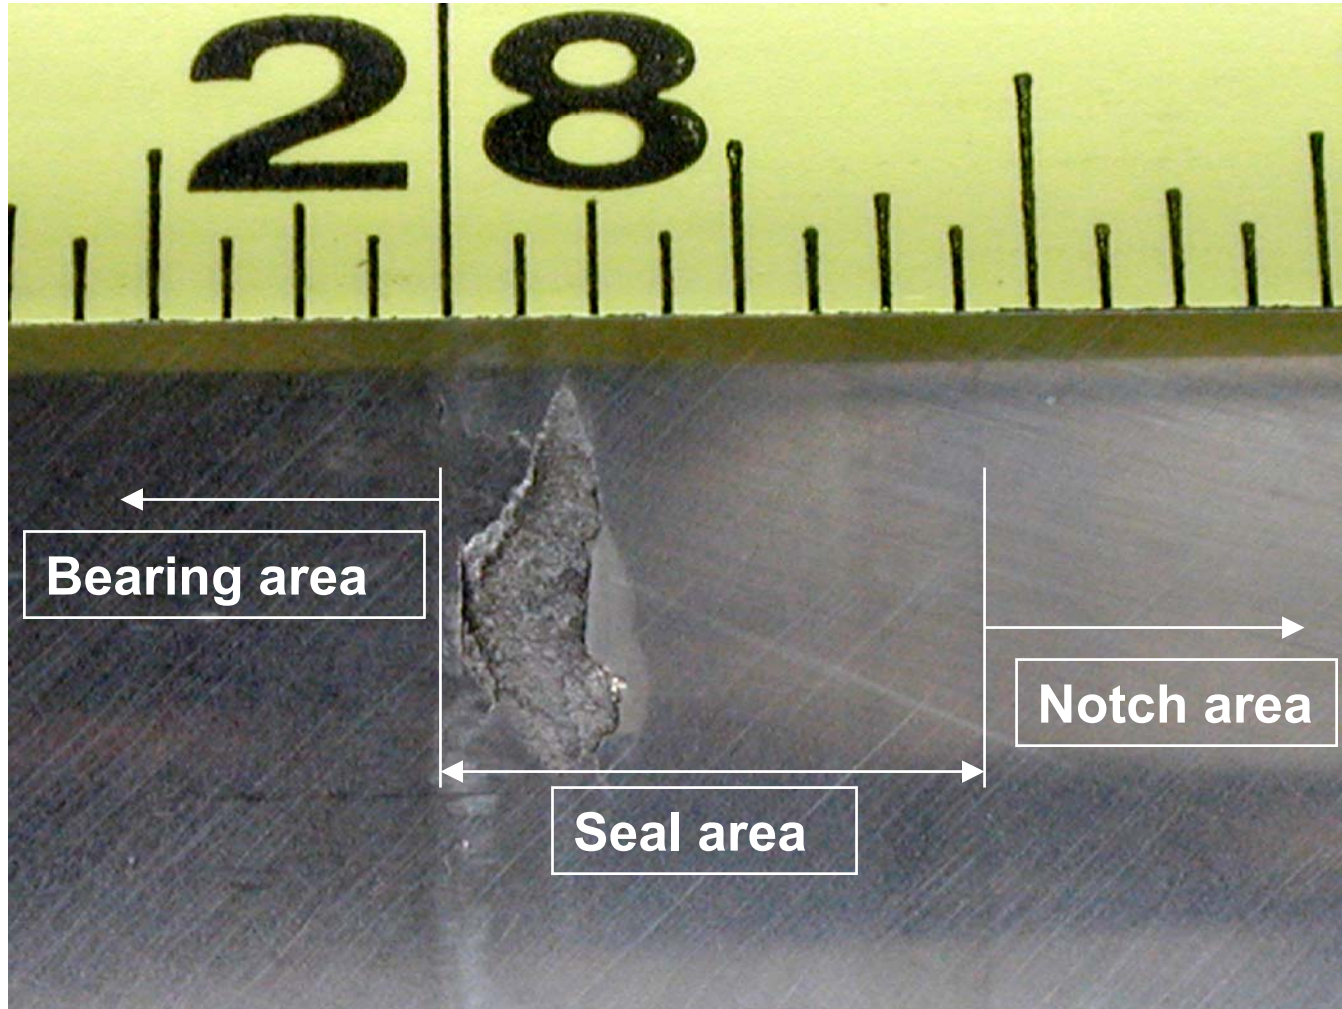
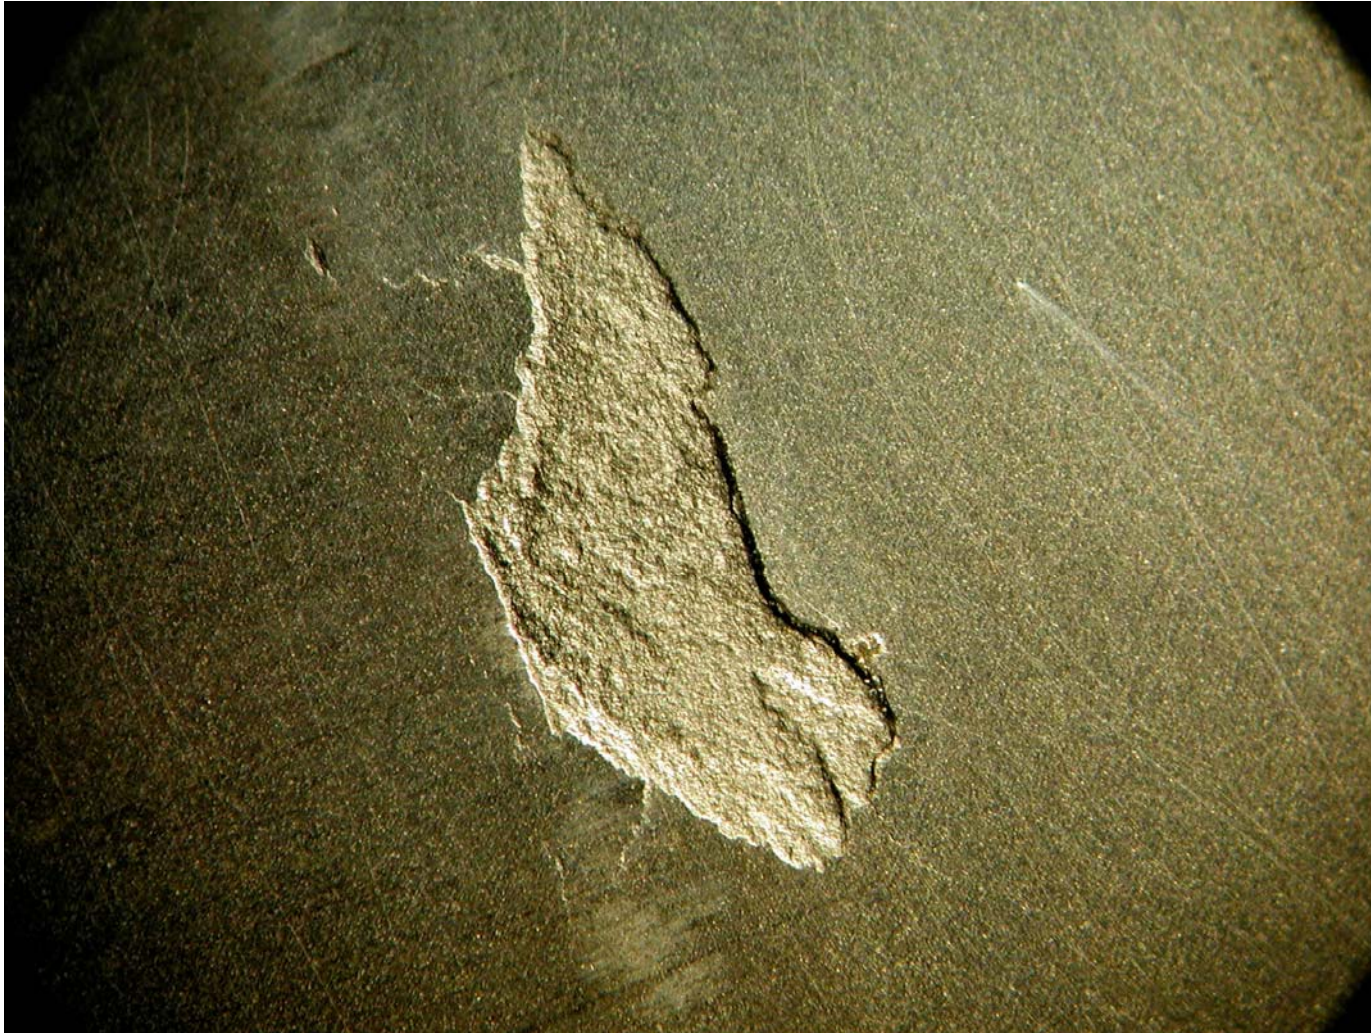
- **1st HVOF coated piston:**
570,000 cycles, i.e. 2 lives, ~ 100ksi at notch
184,500 cycles, ~ 110ksi
- Small area of failed coating (approximately .150" x .350"), between 250,000 - 285,000 cycles at bottom.
- Visual, MPI, LPI and Barkhausen Noise inspection after 570,000 cycles did not find evidence of substrate cracking.
- **Piston failed at bearing contact point**

HVOF COATING AFTER 285,000 CYCLES

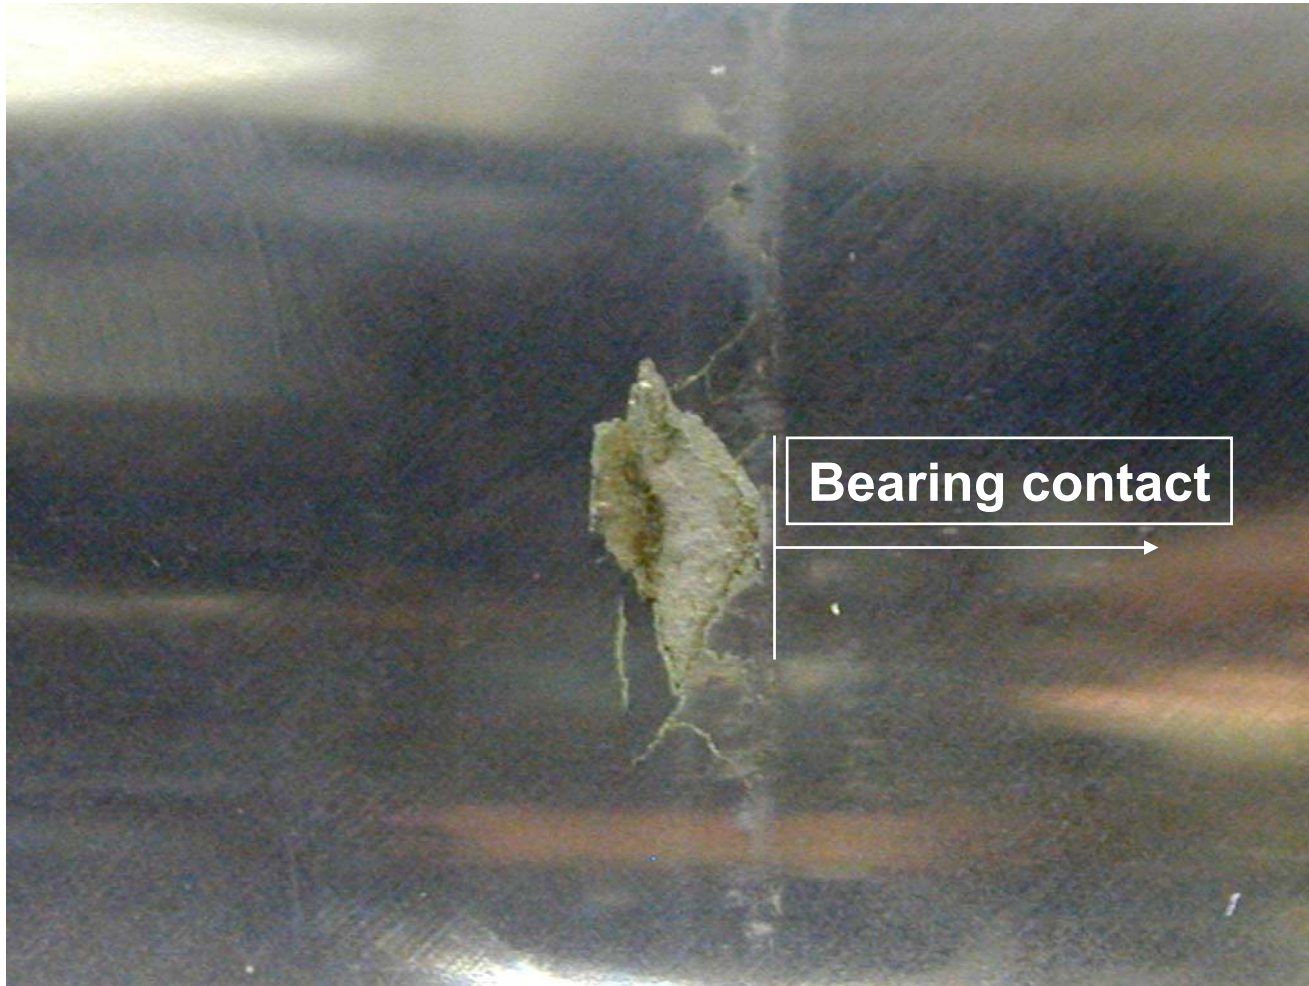
HVOF COATING AFTER 570,00 CYCLES

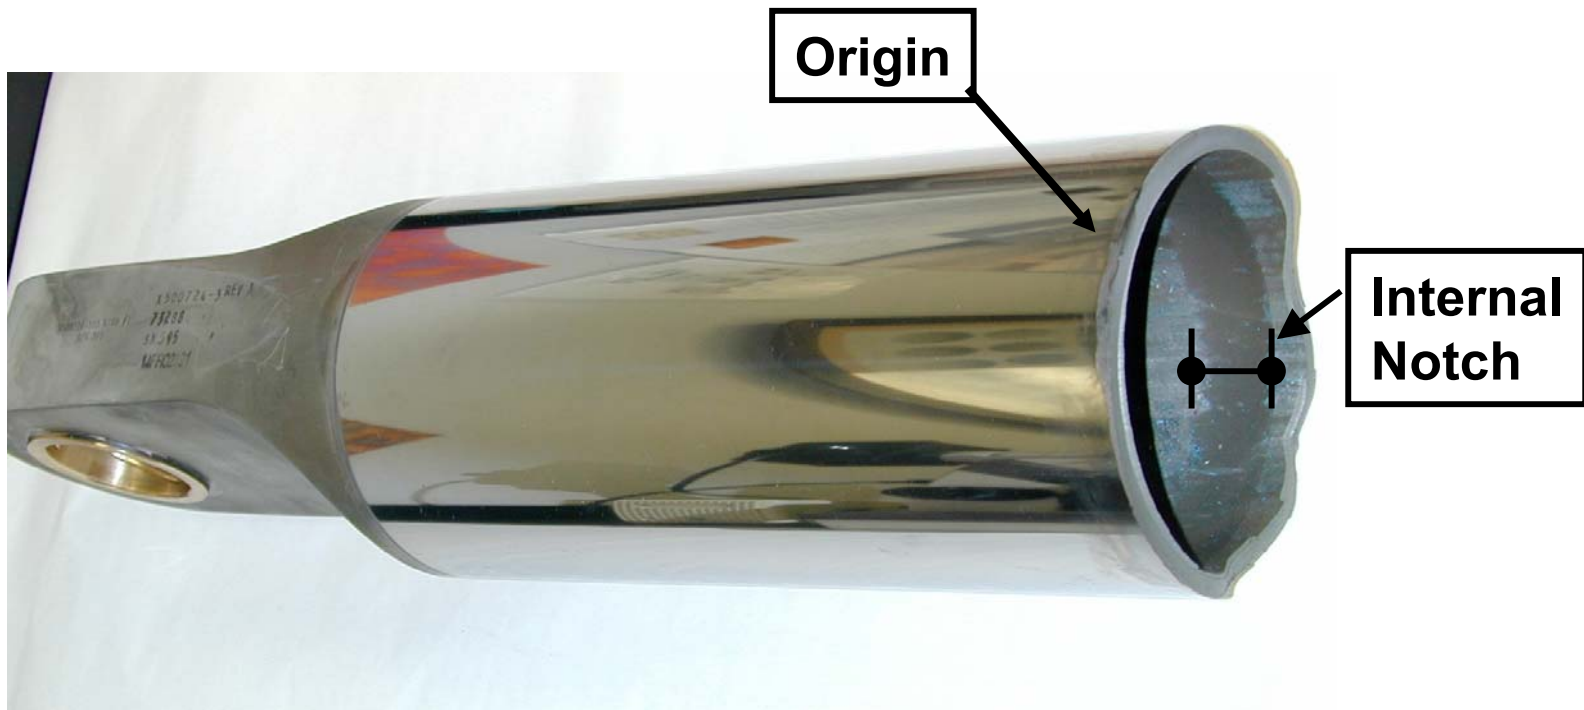
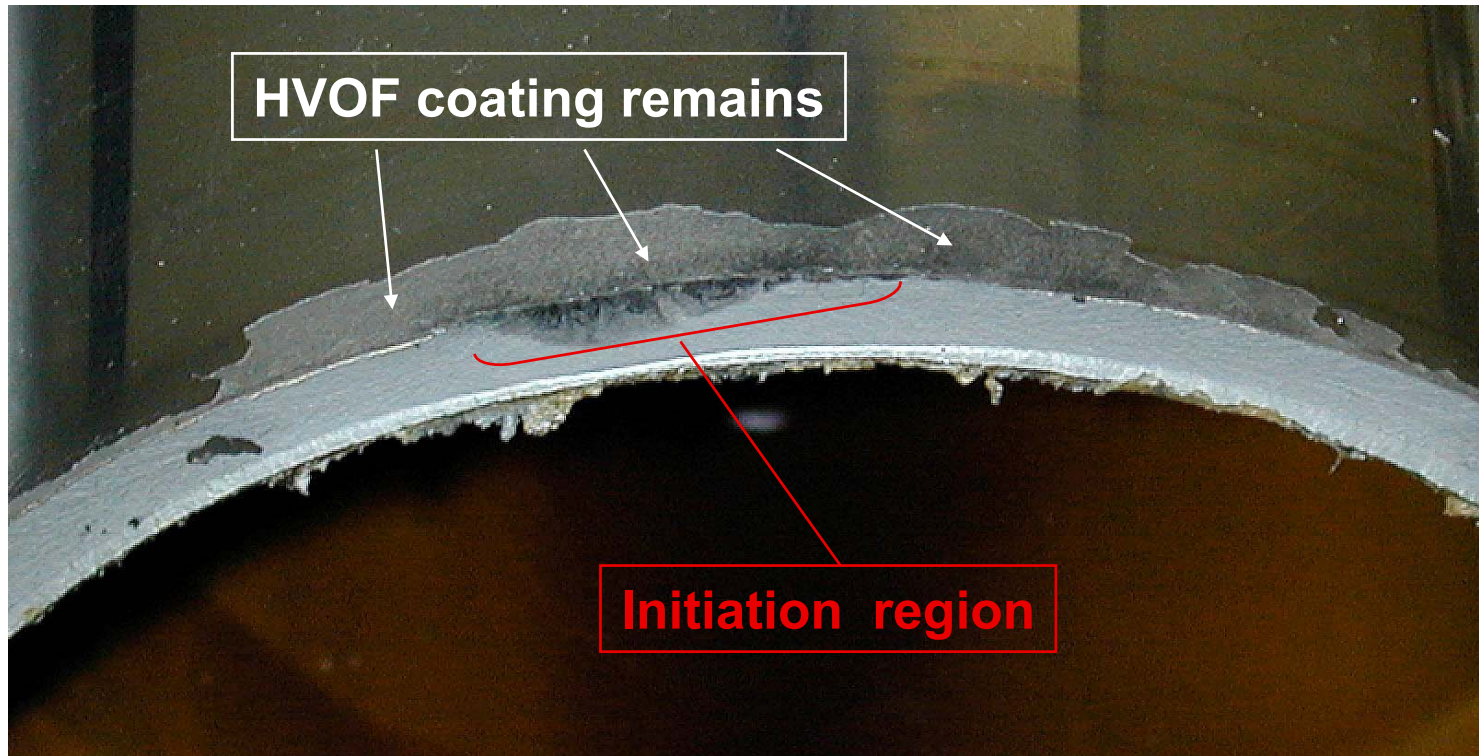
- **2nd HVOF coated piston:**
33,000 cycles. ~125ksi at notch
- **Piston failed at bearing contact point, large area of coating failure 2"x0.25"- top and bottom**

2nd HVOF coated specimen

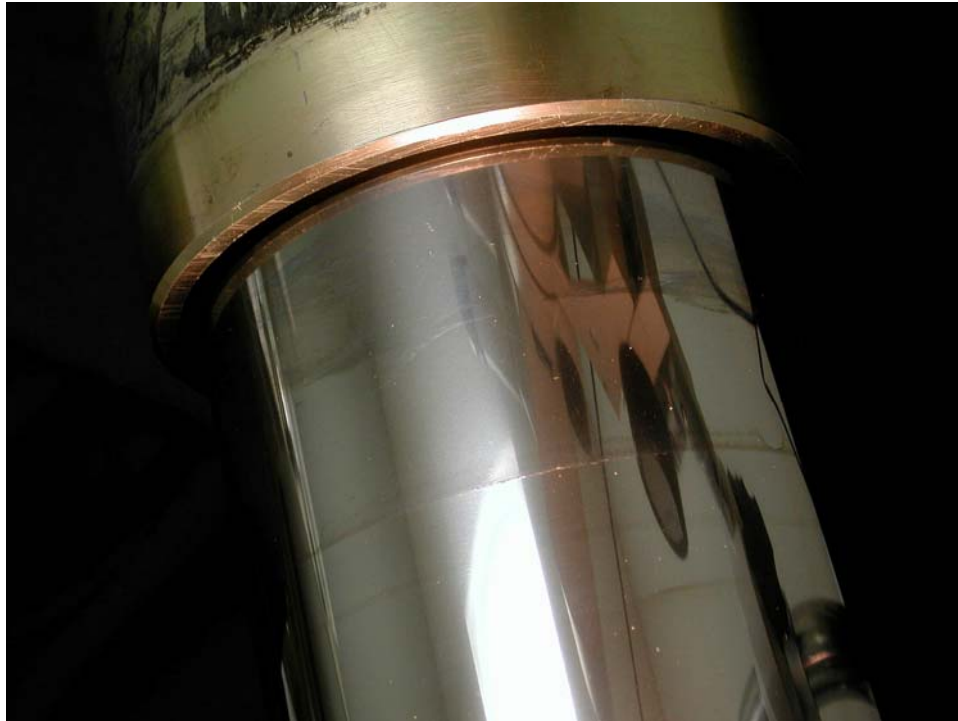
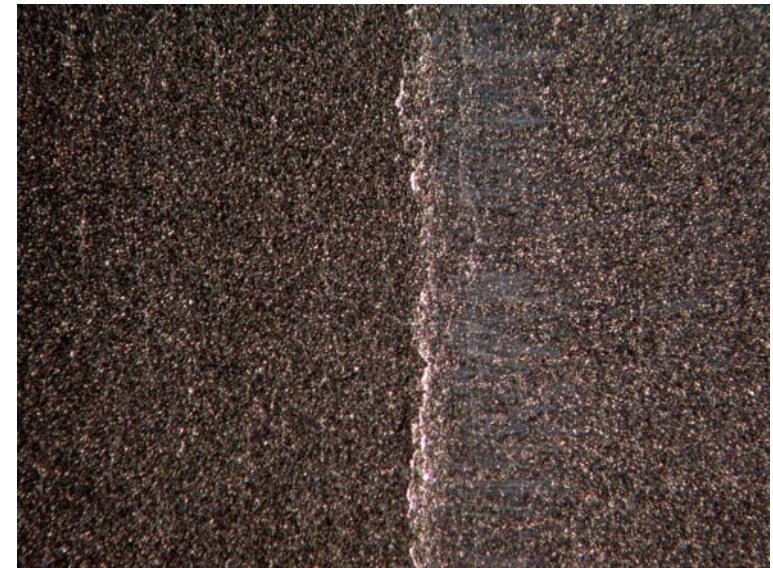
10,000 cycles - significant circumferential cracking

←→
Bearing area

Appearance of coating after 10,000 cycles

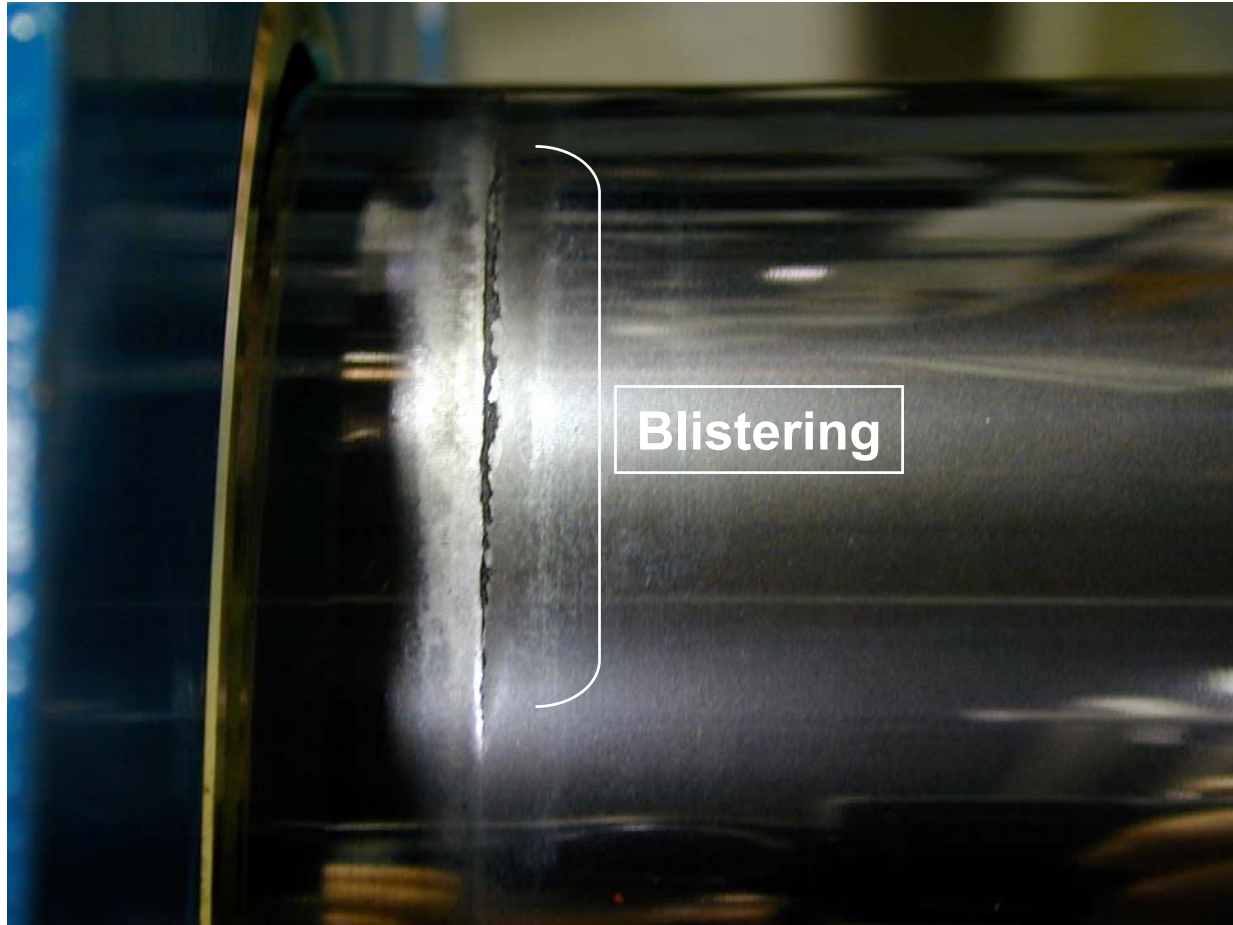
25,300 cycles - failure at the bearing contact point
initiating at bottom

Appearance of coating after 25,000 cycles
